Comments on the collision between a freighter and a U.S. Navy ship offshore Japan

June 2017(chronologically from bottom to top)

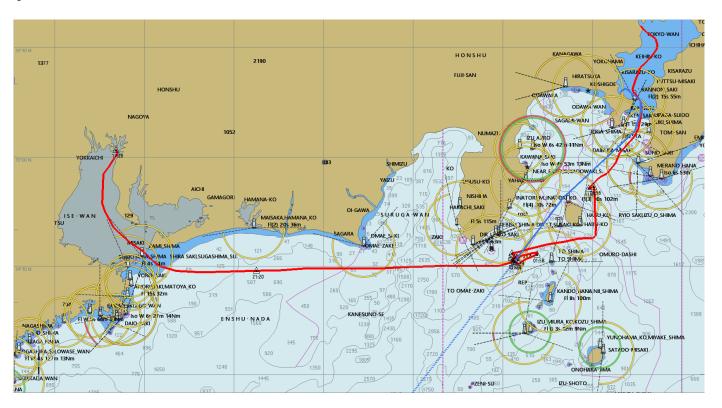
A route passing west of the island of Oshima and then on to the Strait of San Bernardino, or to Okinawa or the Luzon Strait, would have taken USS Fitzgerald through the location where the collision occurred. See the blue route below. The route of ACX Crystal is in red.

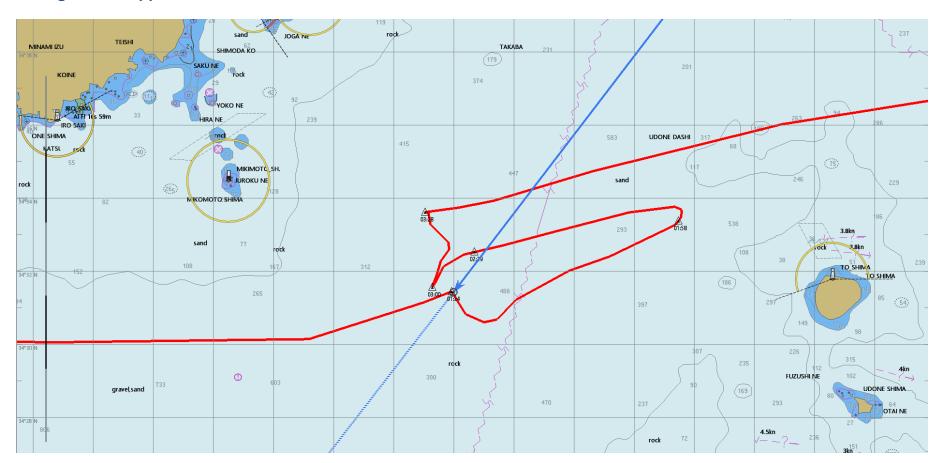
Before the collision, ACX Crystal would be heading 071 and USS Fitzgerald 217. The heading difference is 146 degrees, 34 degrees off opposite routes.

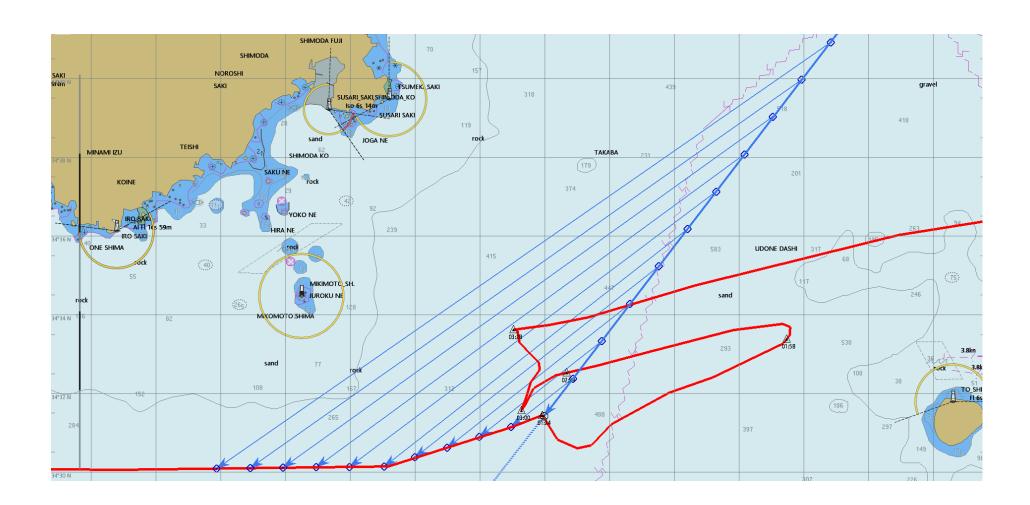
Positions of both ships are plotted below every 3 minutes, assuming that the freighter was going 17 knots at the time, which seems to be the case, and the Navy ship 24 knots. Her maximum speed is in excess of 30 knots, perhaps 35 knots. In routine transit she would sail slower to save fuel.

SSE of Mikimoto, the freighter reached a normal turning point on her route to Tokyo and came 19 degrees to port from 090 to 071. At that point she was about 10 nautical miles from USS Fitzgerald, if the Navy ship's speed was indeed 24 knots, more if the ship was faster, and less if slower.

Now, as seen from the USS Fitzgerald's bridge, 30 minutes before the collision, at t – 30, the freighter's range would have been 19.1 NM, bearing 235, which was 18 degrees to starboard; at t – 27: 17.2 and 234; at t – 24: 15.4 and 234; at t – 21: 13.5 and 233; at t – 18: 11.7 and 233; at t – 15: 9.8 and 232; t – 12: 7.9 and 232; t – 9: 5.9 and 231; t – 6: 4.0 and 232; t – 3: 2 and 232. Clearly, the freighter was seen at an almost constant bearing, before and after she altered her course by 19 degrees, and the Navy ship should have come to starboard, if only by a few degrees. I would have altered the course by 15 degrees for a few minutes until the freighter was cleared ahead. The freighter did alter course by 19 degrees, but not only did this not make a big difference where bearings were concerned, any experienced mariner in the area would know as a matter of course that traffic south of Mikimoto should be expected to alter course a few degrees to portside to remain on route to the ports of the Tokyo Bay area.

At the last moment, when the collision appeared to be unavoidable, USS Fitzgerald came hard to port, and ACX Crystal hard to starboard, the usual last minute reflex. The pictures of the damage sustained by the two ships seem to corroborate this scenario. After the collision, the Navy ship would be on ACX Crystal's port side.

It is probable that communication between the two bridges was quite deficient, and at any rate none called the Japanese Coast Guard, apparently. The moon had just risen and was 21 degrees only above the horizon, azimuth 116, so there was probably not enough light to see the other ship clearly. It is likely that after resuming her course, the freighter tried to learn the identity of the other ship, which took apparently 34 minutes. By now she was going 13 knots, She turned around and headed toward the location, this time going 12 knots. At 02:30 she was near the location, by now realized the situation and called the Japanese Coast Guard. She stopped at 03:00, and then put her engines possibly slow astern, going about 5 knots, probably in order not to drift. The wind was NE, reportedly 20 to 25 knots, from my meteorological data. At 03:30, probably after talking to her owners and agents and the Japanese Coast Guard, and possibly with the Navy ship, she resumed course toward Tokyo.

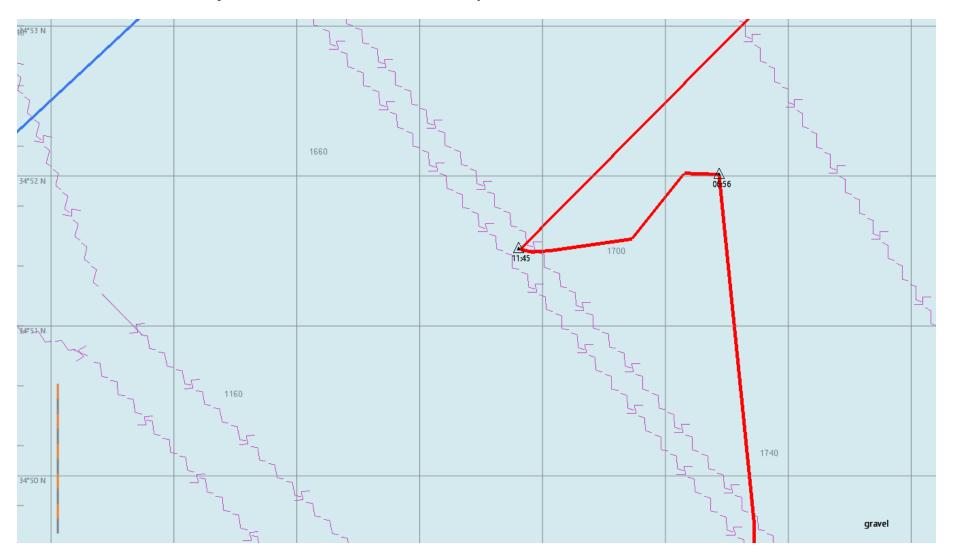
At 07::00, ACX Crystal stopped again, this time for almost 5 hours, and drifted WSW 1.5 nautical miles. She had possibly been instructed to do so by either her owners and / or the Japanese Coast Guard.

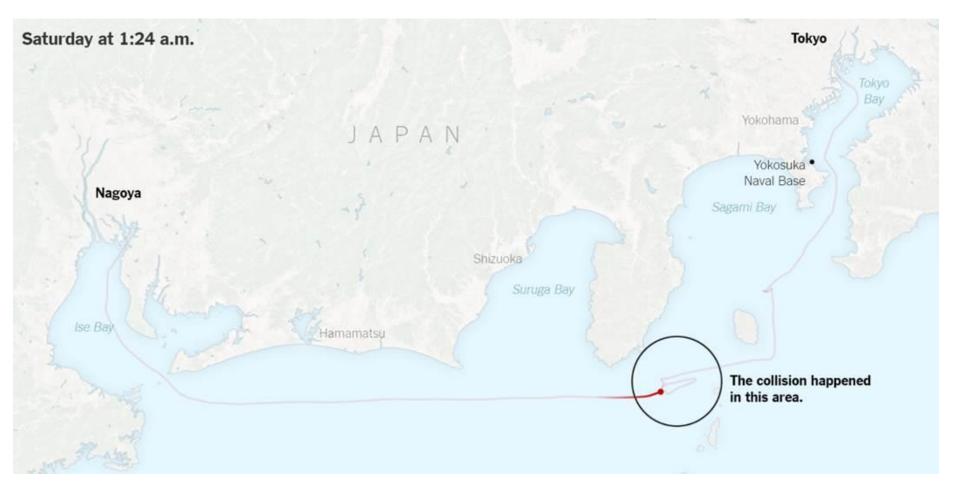
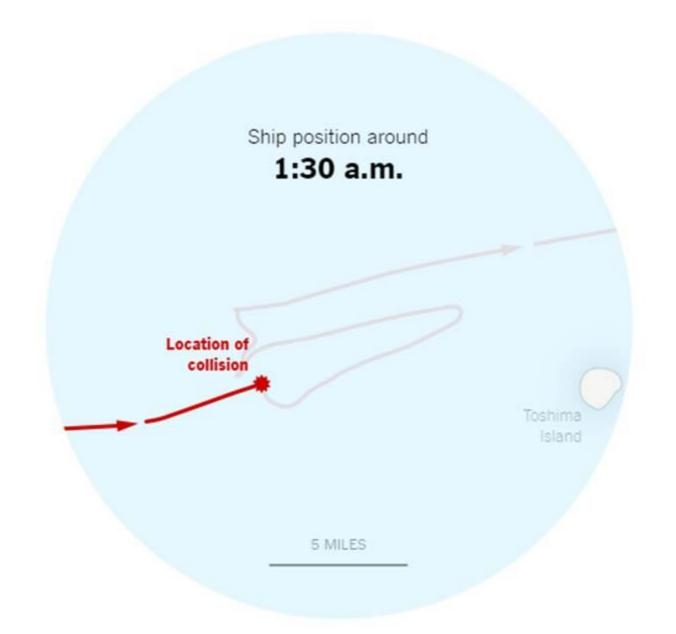
Charts from the New York Times this morning. There is an animation of the newspaper page that provides the timing.

From pictures distributed by the press, it seems the freighter hit the Navy ship which was coming from portside. The US Navy ship was hit on her starboard side. It appears the freighter's route was deflected naturally to starboard after she was hit on her portside bow, before she resumed her course. During that time she most probably communicated, or tried to, with the Navy ship on Channel 16. After 30 minutes she turned around back to the collision scene, either because the Navy ship asked her to, but hadn't asked before, or because there was no response, and when she arrived on the scene she called the Japanese Coast Guard. It appears the Navy ship did not call the Coast Guard, although ACX Crystal probably assumed she had. When on site, it seems ACX Crystal went astern for a while. She finally left the scene at 3:28 AM, after having been on site one hour. I cannot imagine that the US Navy ship had not agreed to her leaving.

- Time of collision: 1:24 AM
- Time ACX Crystal turns around: 1:58 AM
- Time ACX Crystal is back on the collision scene: 2:29 AM
- Time ACX Crystal leaves the scene: 3:28 AM
- Time ACX Crystal apparently starts turning around again: 6:56 AM
- Distance ACX Crystal sails SSE: 1 NM
- Distance ACX Crystal sails ENE: 6.4 NM (13 knots)
- Distance back: 5.7 NM (11 knots)
- Apparent speed before collision: 17.4 knots

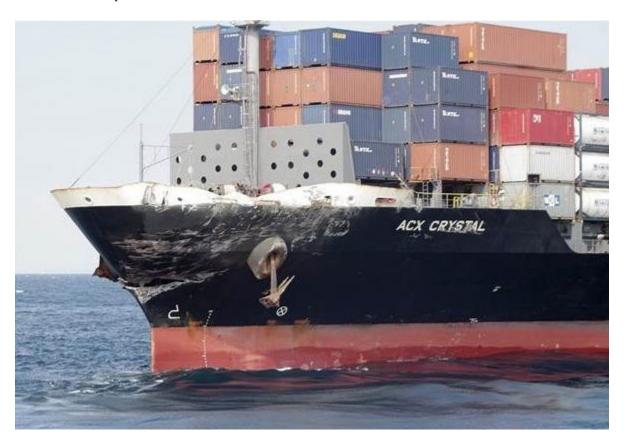
The freighter's bow was hit on her portside

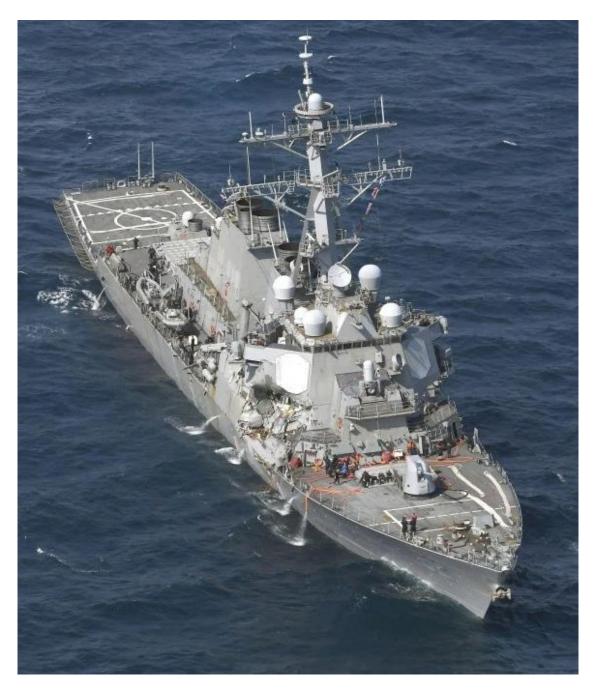
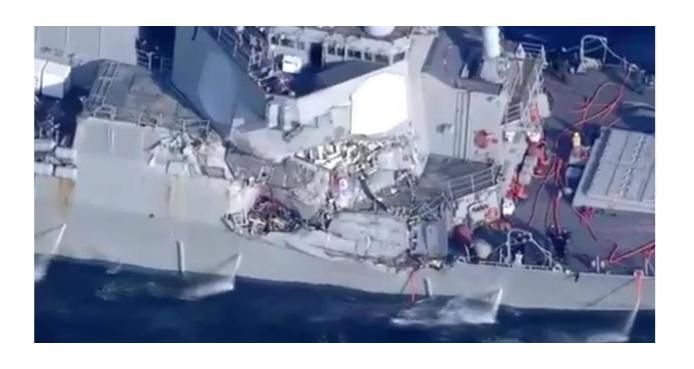
USS Fitzgerald sustained heavy damage on her starboard side, in the collision with the containership which suffered damage on her port bow. Even if the portside and mast lights on the containership were malfunctioning, the Navy ship has ample ways of detecting any traffic, especially so close to it. Wind was NE 15-20 kts, apparently no fog. The area sees very heavy traffic at all times. It is the landfall to Yokohama and Tokyo Bay.

The Navy Ship was hit on her starboardside
