## Suez: hardly a maritime surprise

## March 28, 2021

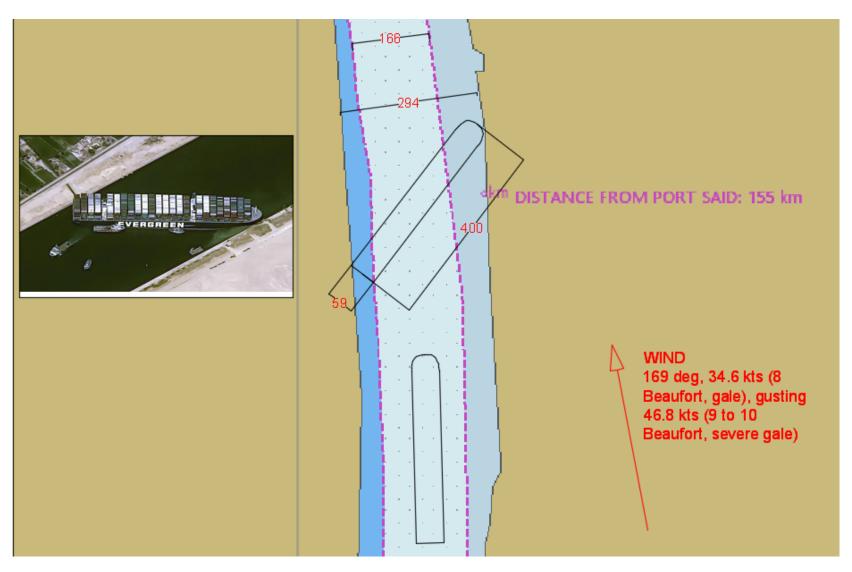
## **Marine chart at location**

You will see on the drawings that the canal on location is 294 meters wide between banks, or berms, but the navigable channel is only 166 meters wide.

In other words, the ship had no business at all being in the canal and should have remained at anchor in Suez Bay until the weather improved a few hours later.

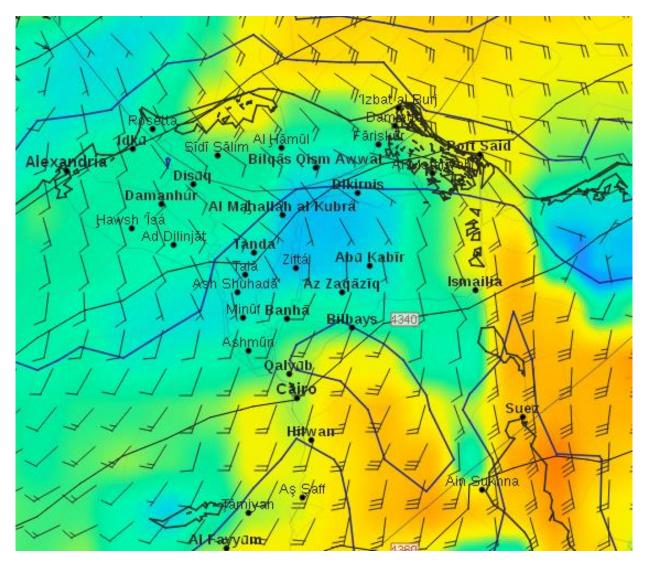
Weather forecast map and table March 23, 2021, at 06:00 UTC

Wind: south (169°), 34.6 knots sustained (Beaufort 8, gale), gusting 46.8 knots (Beaufort 9 to 10, severe to whole gale)

The wind was forecast to blow exactly as a tailwind, which is not a good configuration for any ship.

I calculate that with a 34.6 knots wind, and given the height and length of the ship, the beam force on the ship would have been 290 metric tons, and 530 tons in the gusts.

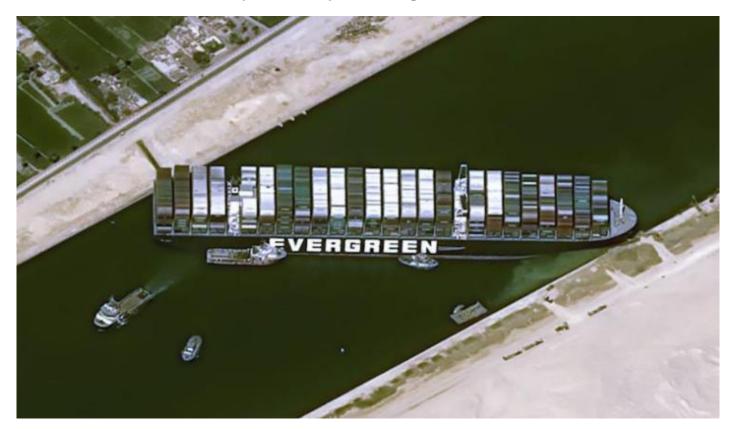
Either the canal is too narrow for the ship or the ship is too large for the canal.

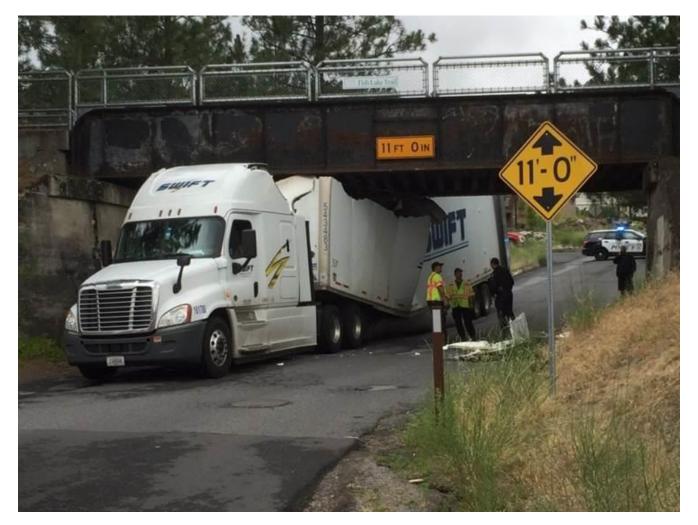
Either the bridge is too low for the rig or the rig is too tall for the bridge or someone couldn't read.
