Comments on the collision between a freighter and a U.S. Navy ship offshore Japan

June 2017(chronologically from bottom to top)

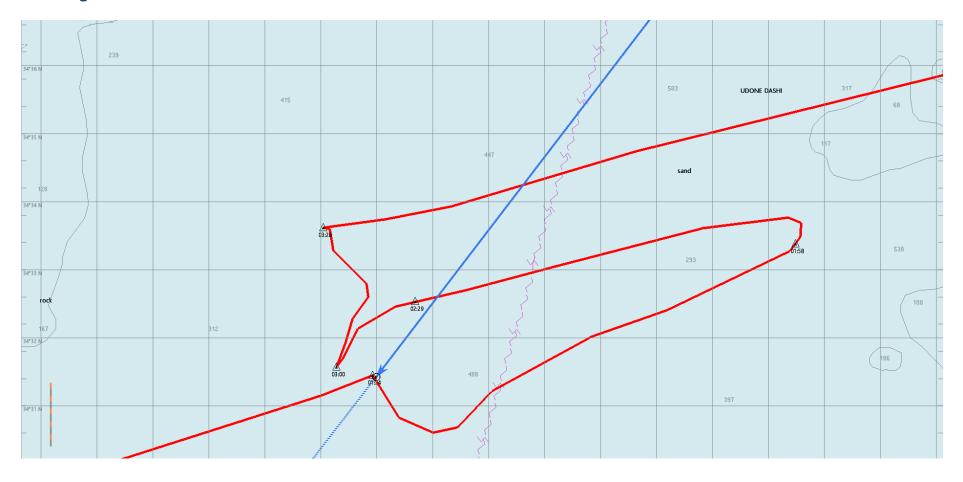
Zooming in

Positions of both ships are plotted below every 3 minutes, assuming that the freighter was going 17 knots at the time, which seems to be the case, and the Navy ship 24 knots. Her maximum speed is in excess of 30 knots, perhaps 35 knots. In routine transit she would sail slower to save fuel.

SSE of Mikimoto, the freighter reached a normal turning point on her route to Tokyo and came 19 degrees to port from 090 to 071. At that point she was about 10 nautical miles from USS Fitzgerald, if the Navy ship's speed was indeed 24 knots, more if the ship was faster, and less if slower.

At the last moment, when the collision appeared to be unavoidable, USS Fitzgerald came hard to port, and ACX Crystal hard to starboard, the usual last minute reflex. The pictures of the damage sustained by the two ships seem to corroborate this scenario. After the collision, the Navy ship would be on ACX Crystal's port side.
